**FREE TRADE INTERNATIONAL BRIDGE
AT LOS INDIOS
ANNUAL INSPECTION REPORT**

**SUBMITTED TO:
CAMERON COUNTY
BROWNSVILLE, TEXAS**

**SUBMITTED BY:
STRUCTURAL ENGINEERING ASSOCIATES, INC.
SAN ANTONIO, TEXAS**

FEBRUARY 25, 2013

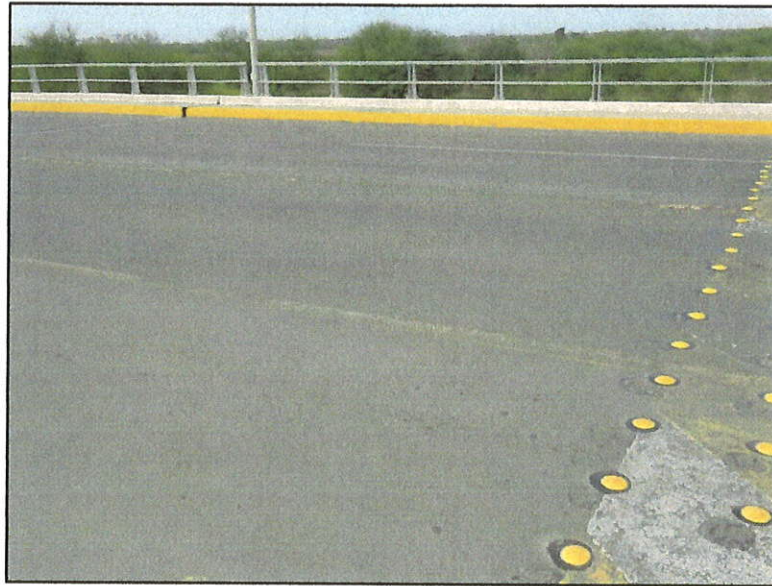
Figure 3.1.1–A (Mexico)

There are minimal visible cracks and pitting in the deck surface. It is slightly worn but overall the deck surface appears to be in good condition. The asphalt overlay appears to be structurally adequate. The lane stripes are visible on the U.S. side, but barely noticeable on the Mexican side of the bridge. Figure 3.1.1–A shows an overall view of the deck on the Mexican side with faded striping while Figure 3.1.1–B shows typical minor cracking found in the deck. Figure 3.1.1–C shows traffic buttons missing from the international border designation.

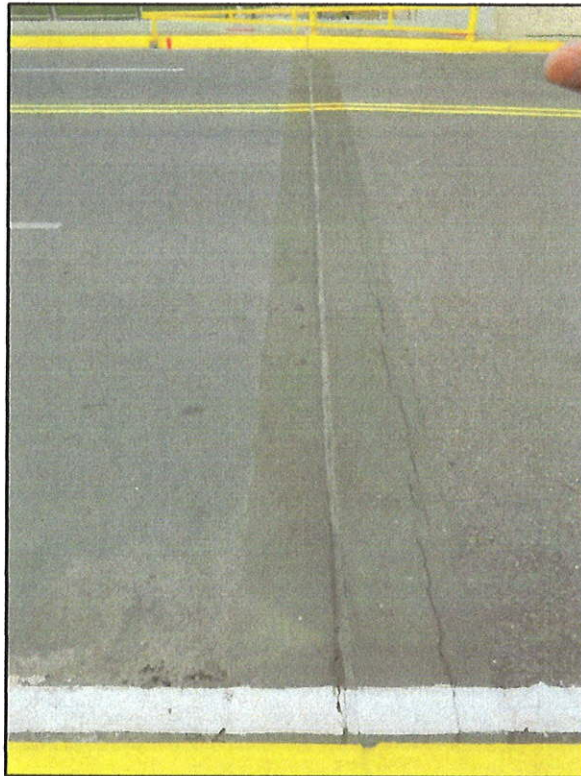
Figure 3.1.2-A (U.S.)

The majority of the bridge joints are in satisfactory condition with a few notable exceptions on the Mexican side of the bridge. Figure 3.1.2-A shows abutment 1 with a crack in the approach slab running parallel to the joint.

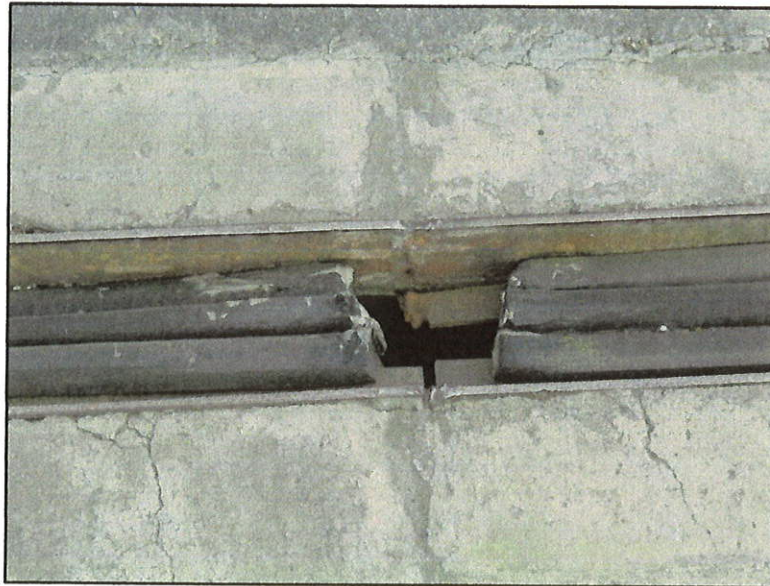
Figure 3.1.2-B (Mexico)

Figure 3.1.2-B shows the bent 3 expansion joint. Note the depressed rubber seal and gap in the joint as well as cracked concrete at the joint.

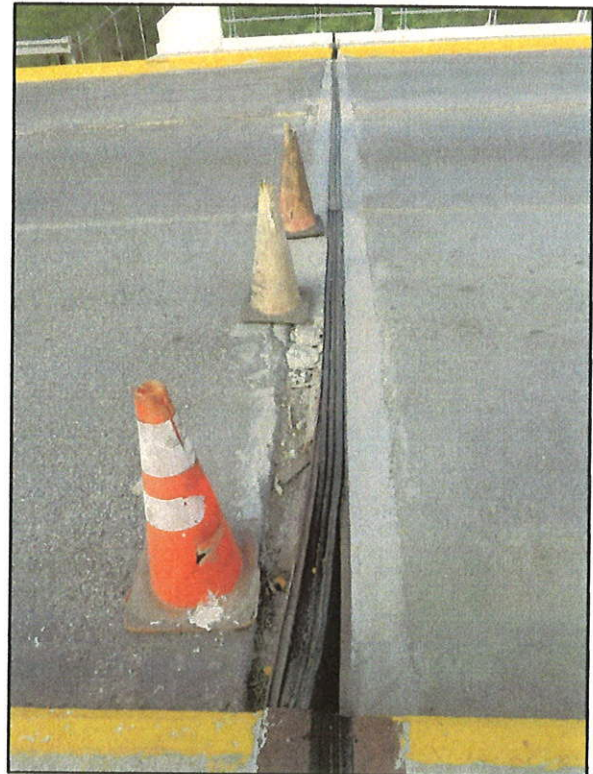
Figure 3.1.2-C (Mexico)

Figure 3.1.2-C shows extensive damage to the expansion joint at abutment 1. The damage is located on the northbound lanes near the sidewalk and is severe enough that one lane is closed to traffic. The damage includes a bent steel plate, bent and broken studs, damaged seal and missing grout around the joint. This joint requires immediate repairs or replacement before traffic can resume on the northbound lane.

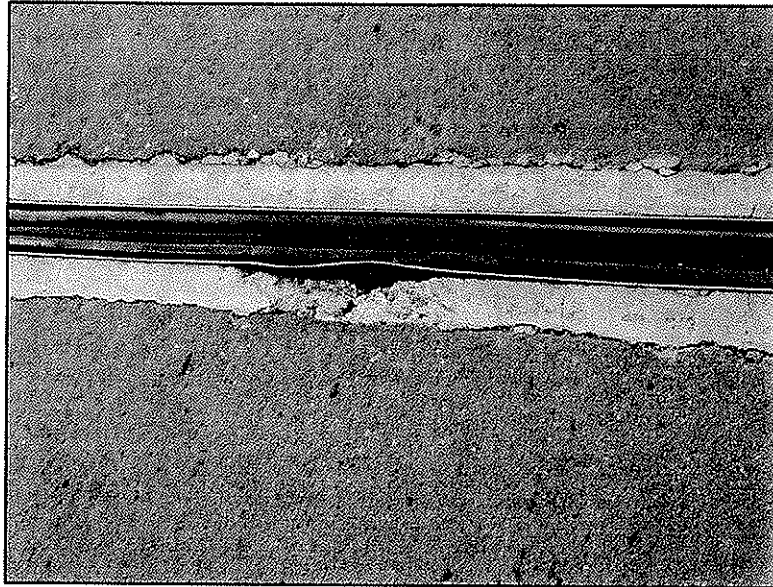
Figure 3.1.2–D (Mexico)

Figure 3.1.2-D shows damage to the expansion joint at bent 2 southbound lane, near the sidewalk. Note the bent plate and spalled grout at this location.

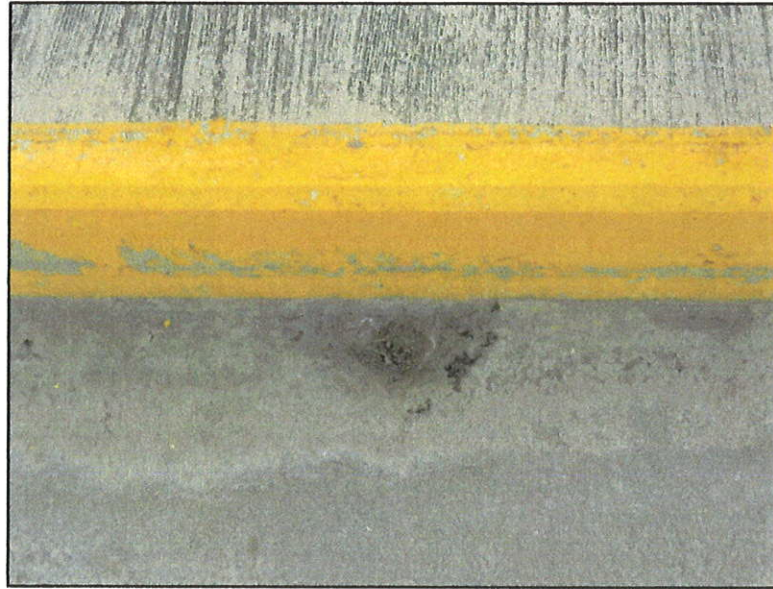
Figure 3.1.3-A (Mexico)

The bridge drains are located alongside the curb on both sides of the bridge. The drains on the Mexican side of the bridge have a smaller diameter than the U.S. drains. Most of the Mexican drains were partially or totally blocked. Figure 3.1.3–A shows an example of a drain, on the Mexican side, that is 100% clogged. All clogged bridge drains should be either cleared out as a short term solution or perhaps larger drain pipes are required as a long term solution. Overall the bridge drains appear to be in fair to satisfactory condition.

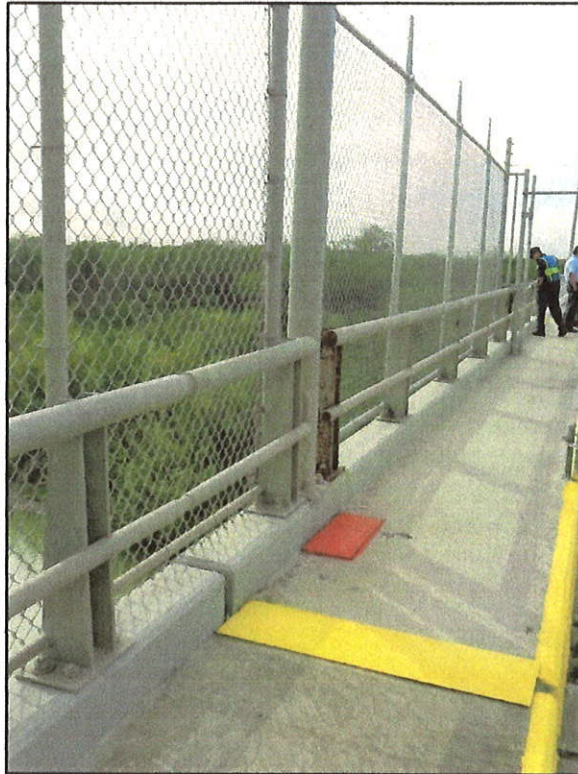
Figure 3.1.4-A (U.S.)

Figure 3.1.4-A shows as example of a sidewalk expansion plate that is not flush with the concrete sidewalk. This plate is located at bent 4 on the east side of the bridge.

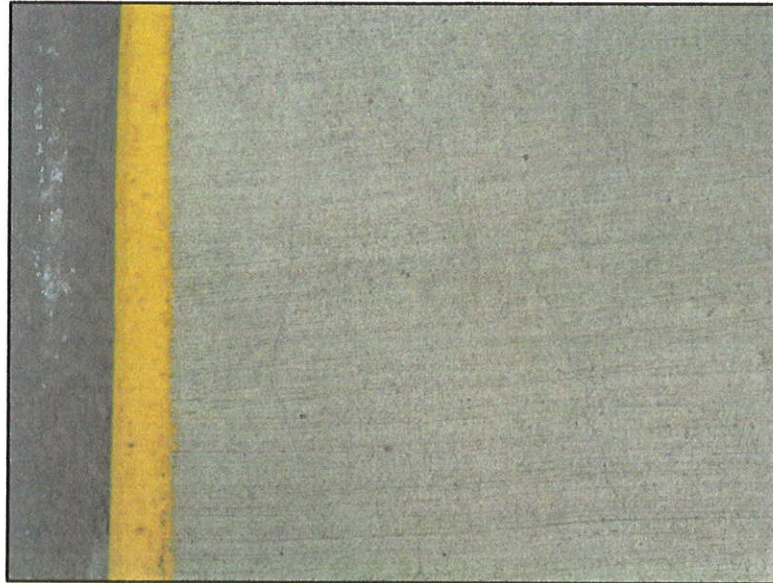
Figure 3.1.4-B (Mexico)

Figure 3.1.4-B shows a typical example of minor cracking. These cracks are located along span 3 at the east side of the bridge.

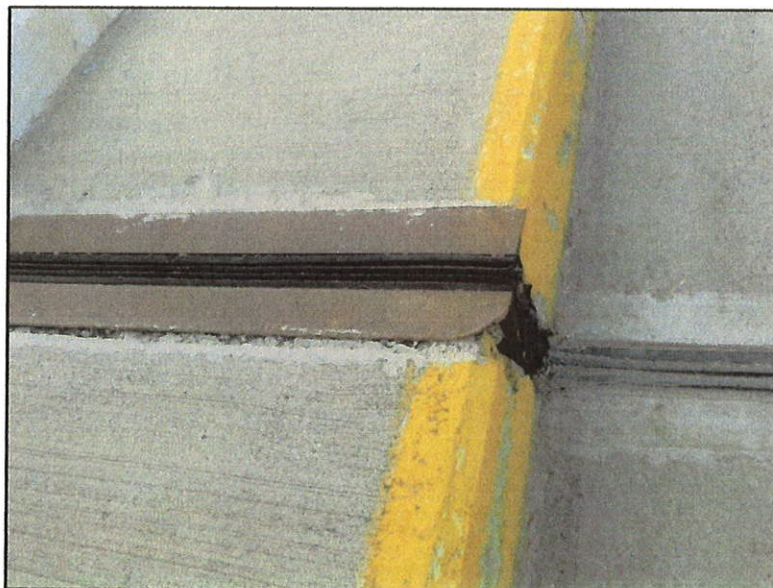
Figure 3.1.4-C (Mexico)

A concrete sidewalk runs along the east and west edge of the bridge roadway. The sidewalk has minor cracking, pitting and spalling. In addition, the sidewalk expansion joint cover plate is not flush with the sidewalk at some locations and missing at other locations. See Figure 3.1.4—C for one location that has a bent expansion joint plate at the sidewalk. Also at one of the light poles, a pullbox cover is missing and the box is partially filled with dirt. Another pullbox cover is missing hold down bolts. Overall the curb and sidewalk appear to be structurally adequate and in good condition; however, may require minor maintenance in the near future.

Figure 3.1.4-C shows a rusty sidewalk expansion joint plate that is also bent at one corner. This plate is located at bent 2 on the east side of the bridge.

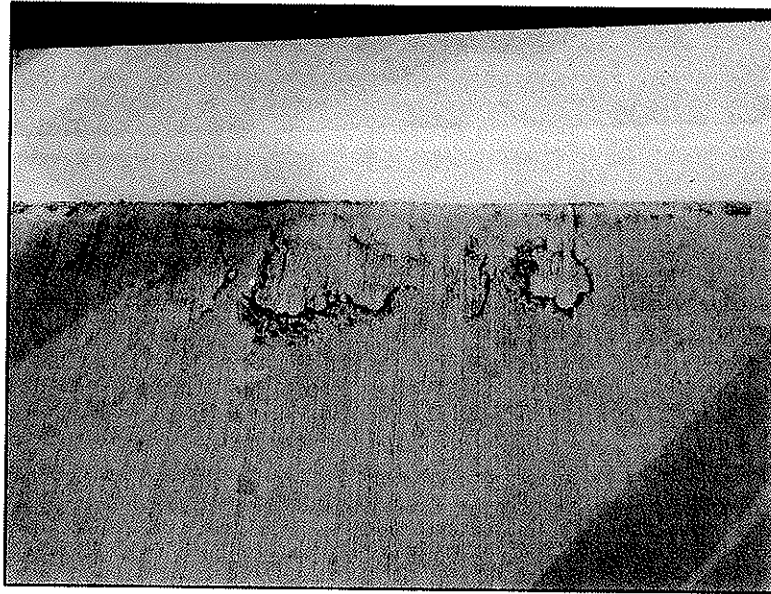
Figure 3.1.4-D (Mexico)

Figure 3.1.4-D shows an example of cracking and spalling in the sidewalk. This damage is located at the span 1 southbound sidewalk.

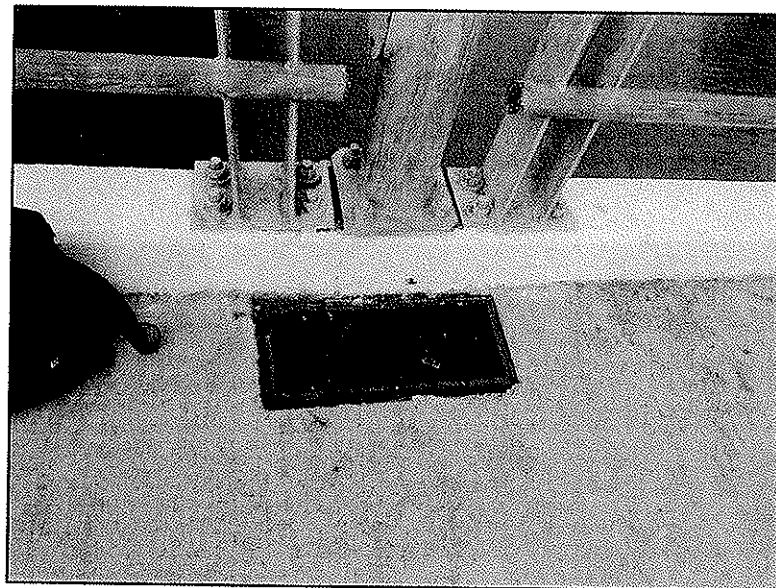
Figure 3.1.4-E (Mexico)

Figure 3.1.4-E shows a pullbox with a missing cover partially filled with dirt. This pullbox is located on the southbound sidewalk on span 3 near bent 3.

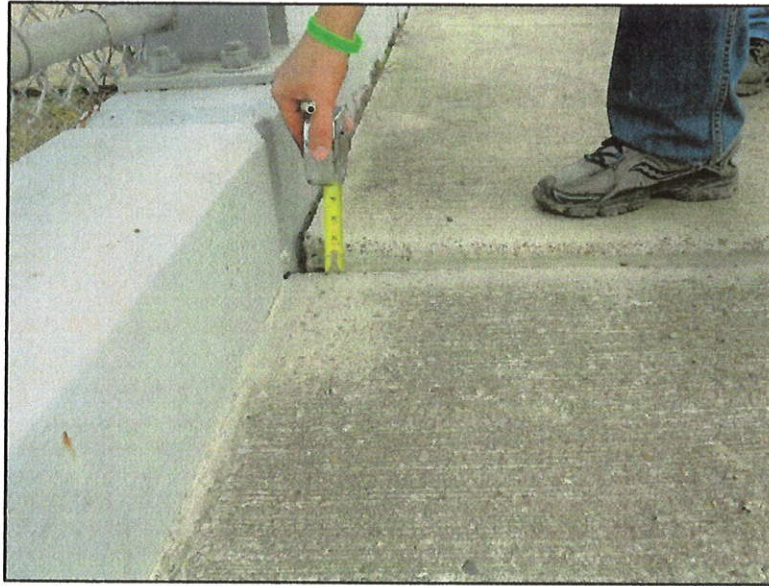
Figure 3.1.4-F (U.S.)

Figure 3.1.4-F is located at abutment 6. It shows differential movement at the sidewalk. Note that the sidewalk on the approach slab is approximately 1 ½" higher than the abutment 6 sidewalk.

No appreciable settlement was observed at the abutments from below the bridge. However, observation from the top of the bridge indicate some differential settlement has occurred at abutment 6, as evidenced by an approximately 1 ½" drop in sidewalk elevation from the approach slab to the bridge abutment, shown in Figure 3.1.4-F.

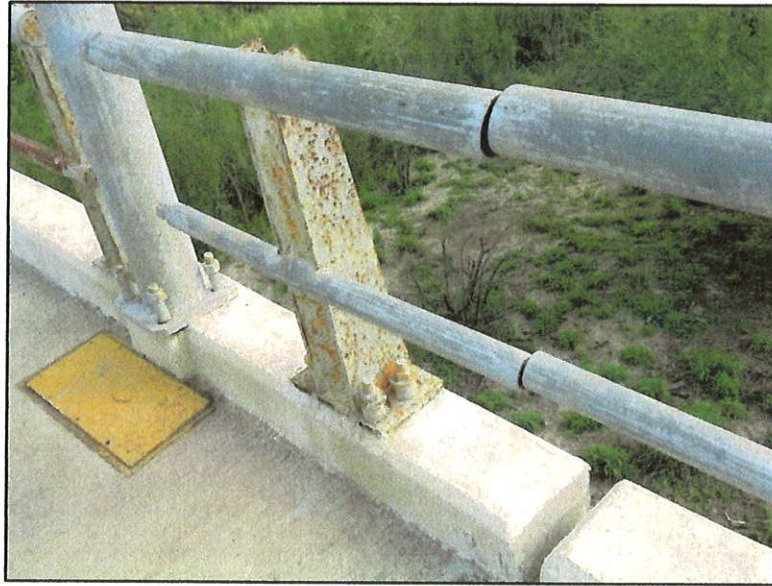
Figure 3.1.5–A (Mexico)

Figure 3.1.5–A shows the northbound rail at bent 3. Note that the rail is missing an expansion piece at the expansion joint and the steel plates, bolts and nuts are rusty.

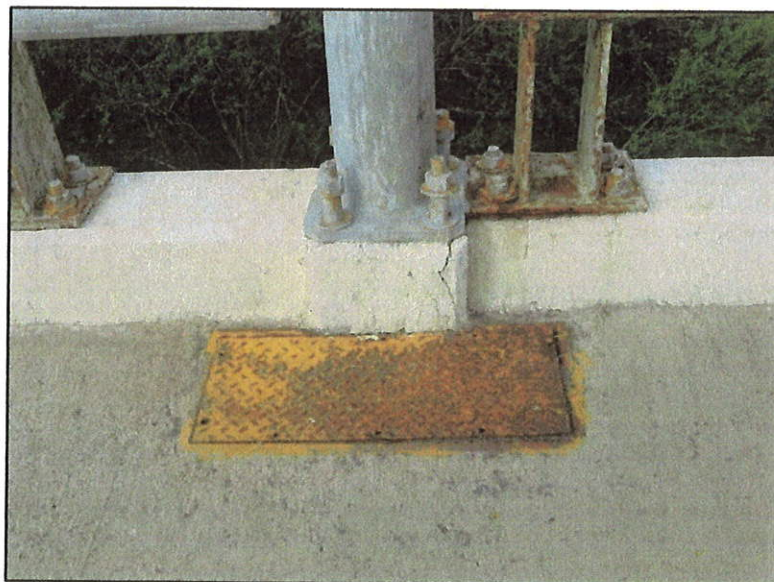
Figure 3.1.5–B (Mexico)

Figure 3.1.5–B shows a light pole concrete pedestal cracked at span 2 on the southbound sidewalk. Also note the rusty rail, bolts, nuts, and pull box cover plate.

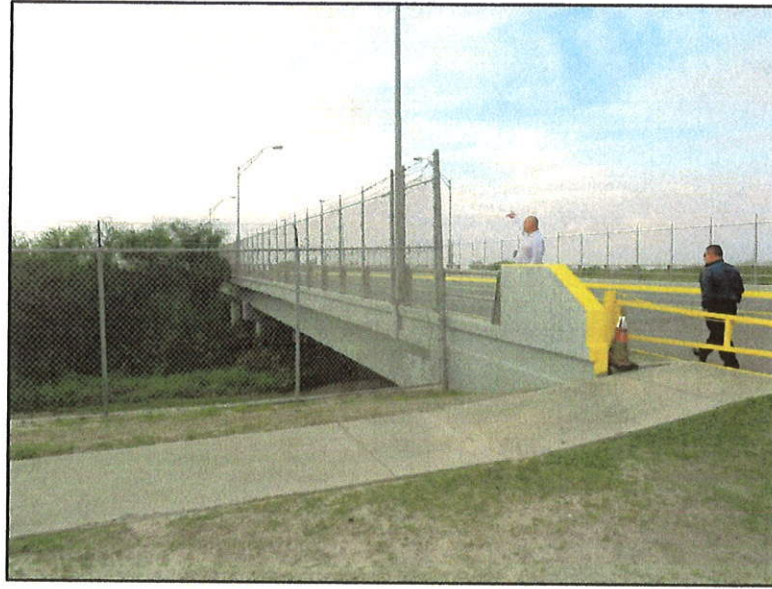
Figure 3.1.6-A (U.S.)

The high fence as seen in Figure 3.1.6–A is only located on the U.S. side of the bridge and appears to be in good condition. The fence is mounted to the bridge behind the traffic rail.

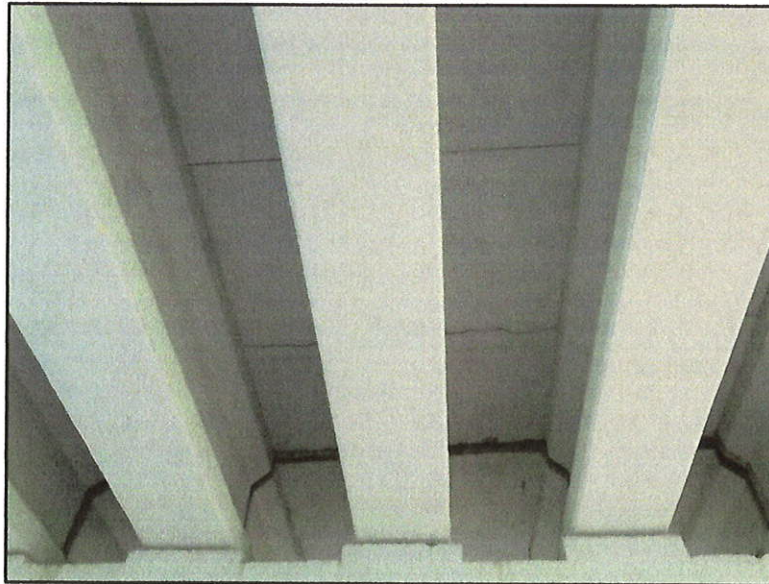
Figure 3.2.1-A (Mexico)

There are minimal areas where visible cracks exist in the precast panels which support the deck. The cracks travel from one edge of the panel to the other edge. The cracked panels are located in span 1 in the second panel from the bent 2 expansion joint. Figure 3.2.1–A shows these cracked panels. Note that the U.S. spans utilize permanent metal deck forming and not precast panels. Therefore, it was not possible to observe the condition of the underside of the deck slab on the U.S. side of the bridge. Overall the slab and diaphragms appear to be in satisfactory to good condition.

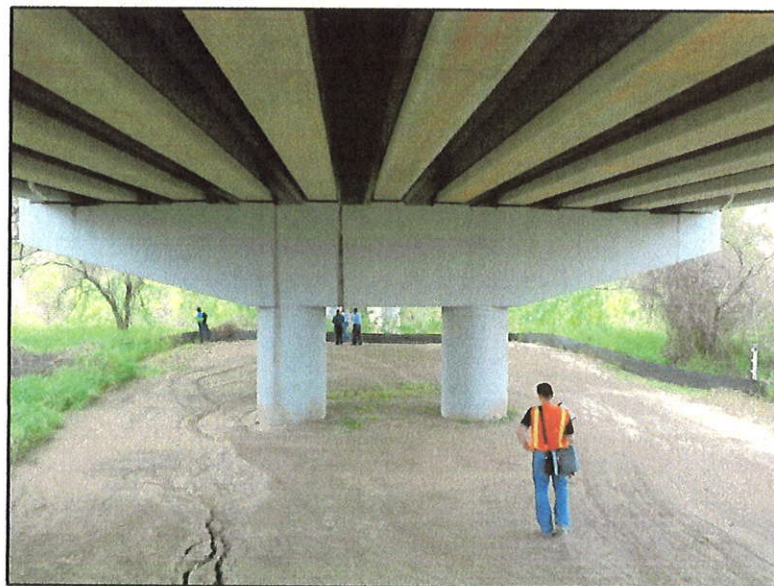
Figure 3.2.2-A (U.S.)

The bridge beams appear to be in good condition. Figure 3.2.2-A shows the beams in span 5. Only minor cracks and stains were observed.

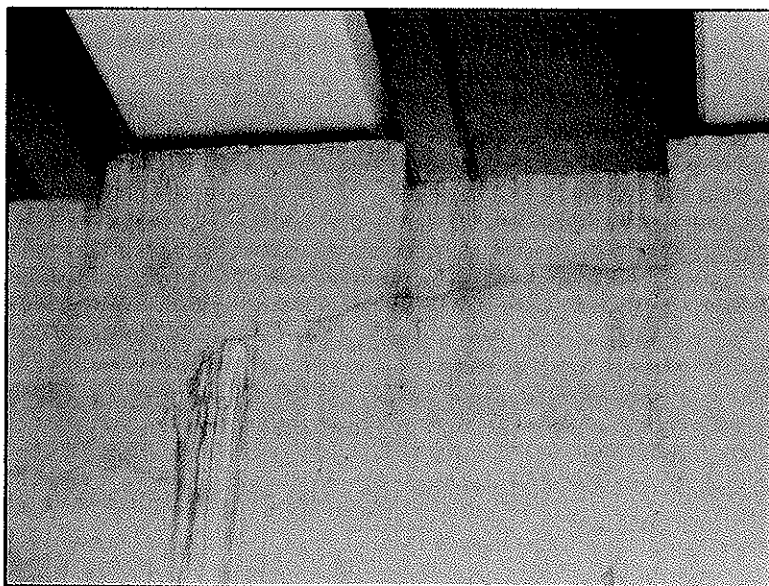
Figure 3.3.1-A (Mexico)

Observation of the bearing seats and bearing pads was limited since no overhead equipment was provided. Observation of the abutment bearing seats and bearing pads was also limited due to confined space around the abutments. There appears to be concrete rubble on top of bent cap 3. Figure 3.3.1-A shows cracking that was found near the bearing seats on bent cap 2. The bearing pads in the abutments, that could be observed, appeared to be structurally adequate.

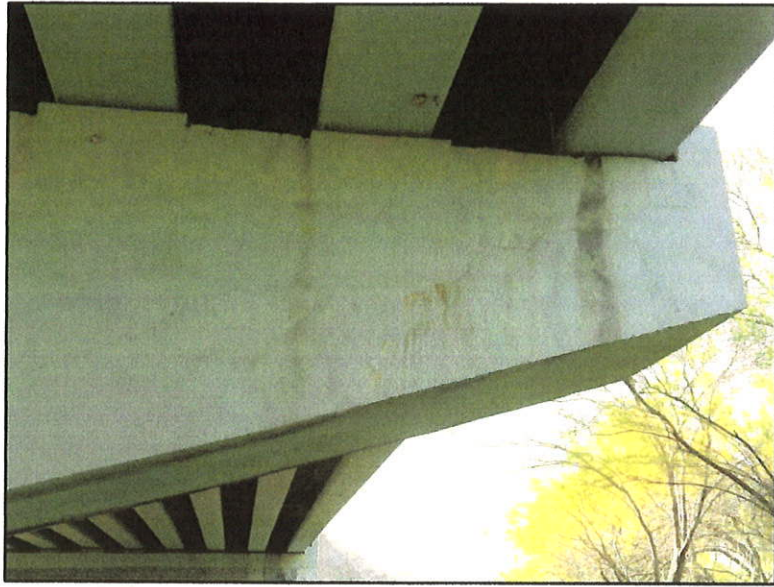
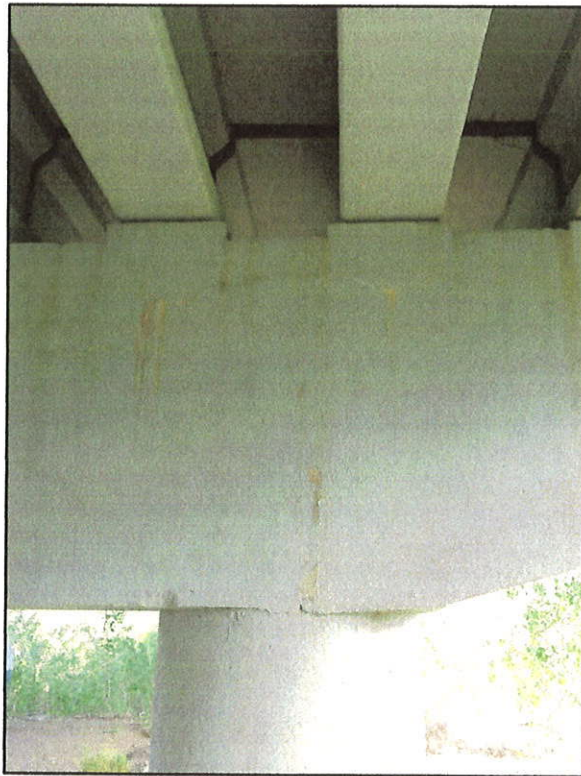
The concrete bent caps appear to be in good condition with the exception of bent 2. Figure 3.3.2-A and 3.3.2-B show bent 2. This bent went through major rehabilitation approximately eight years ago to repair cracks that had appeared in the bent. The cracks were epoxy injected at the cap, columns and foundation. These cracks are either reappearing or new cracks have formed. The cracking appears on both sides of the cap. Also note the staining on the cap which is evidence that the expansion joint is not sealed properly. This type of staining occurs at all bent caps. Bent 2 should be closely monitored and may require maintenance in the near future.

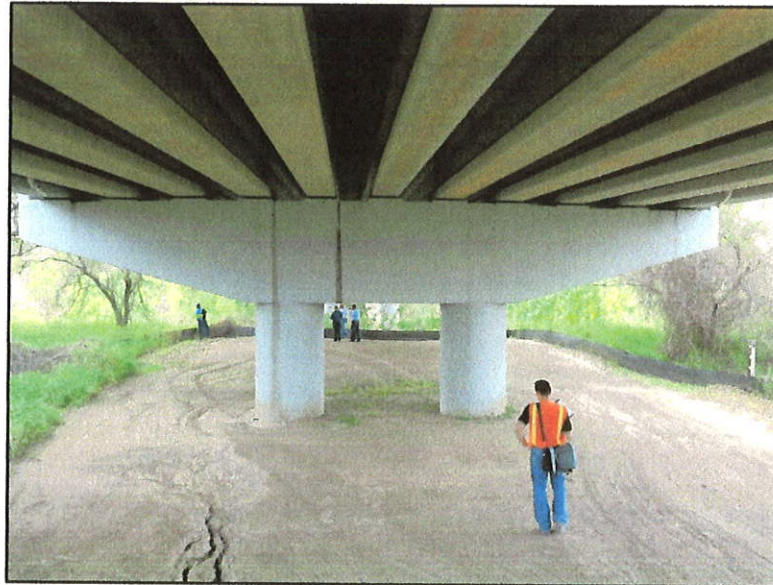
Figure 3.3.3–A (U.S.)

The concrete columns do not appear to have any deterioration that would indicate loss of structural capacity. Overall the columns appear to be in good condition. There is some minor staining on the columns as seen in Figure 3.3.3–A. This staining is caused by leakage in the expansion joints.

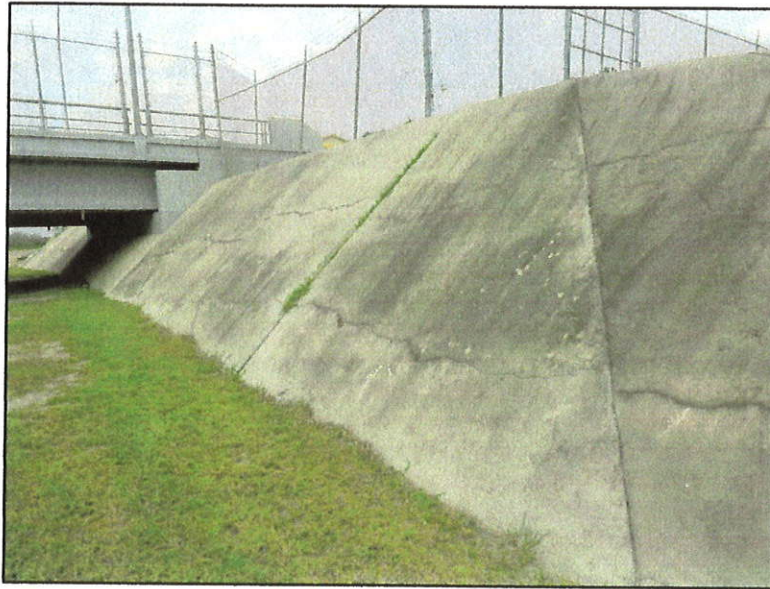
Figure 3.3.4-A (U.S.)

The rip rap directly under abutment 6 has only minor cracking. However, away from the abutment the cracks are more pronounced, as seen in Figure 3.3.4–A. Graffiti covers some of the beams near abutment 6. Figure 3.3.4–B shows cracking at a joint where the ear wall and abutment cap meet. Other than staining on the abutment cap, there is no evidence of problems with the abutment cap, backwall, or wingwall. Overall the abutments appear to be in good condition.

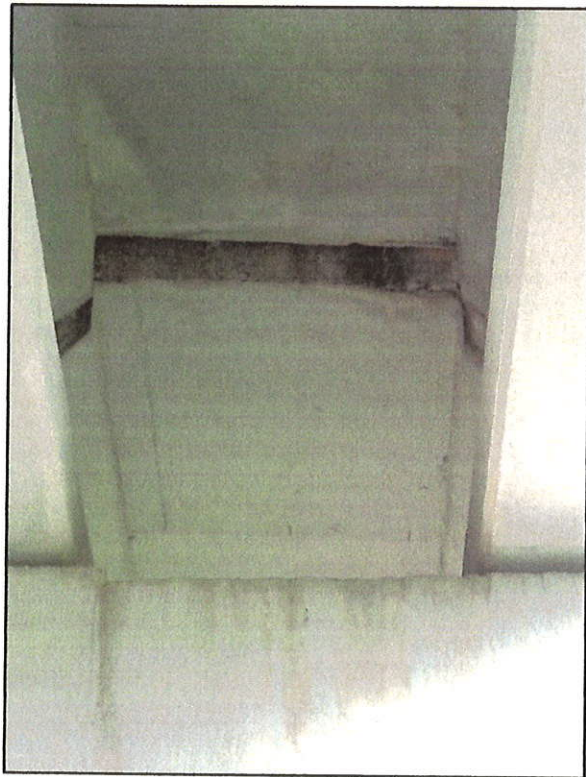
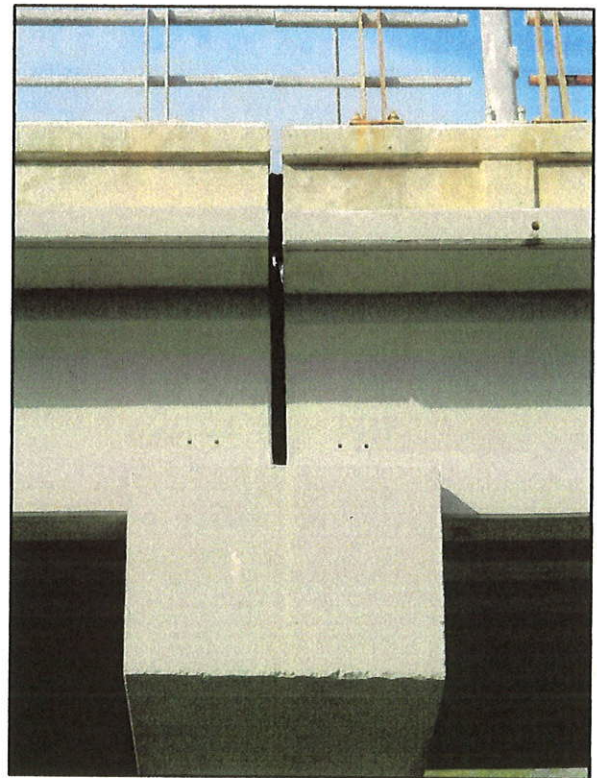
The two concrete columns at each bent are supported on a large concrete mat with multiple deep circular footings under the mat. The bearing seats at bent 2 are lower on the span 2 side and higher on the span 1 side as seen in Figure 3.3.5-A and Figure 3.3.5-B. This is an indication of possible settlement at bent 2. Other bents did not show signs of settlement.
